Ambient Groundwater Quality of the Western Mexican Drainage Basin: A 2016-2017 Baseline Study – May 2017

The Arizona Department of Environmental Quality (ADEQ) Ambient Groundwater Monitoring Program conducted a baseline study to characterize the groundwater quality of the Western Mexican Drainage Basin from 2016-2017. ADEQ carried out this task under Arizona Revised Statutes §49-225 that mandates monitoring of waters of the state including its aquifers. The fact sheet is a synopsis of the ADEQ Open-File Report 17-02¹

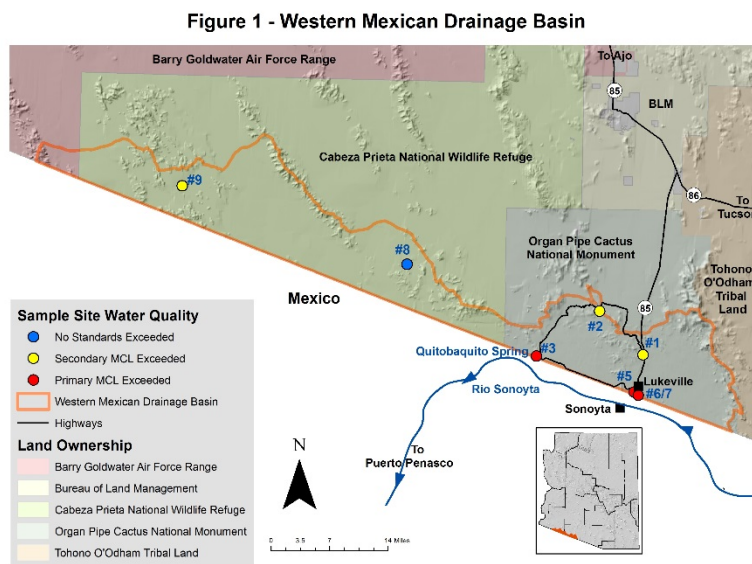
Figure 1 - Western Mexican Drainage Basin

The basin contains 610 square miles within Yuma and Pima counties in southwestern Arizona. The basin comprises a thin strip of land, no more than 15 miles wide, along the international boundary with Mexico (Figure 1). The majority of the Western Mexican Drainage basin lies within Mexico.

Motel Well (#7), Papago Well (#8), and Tule Well (#9)([Figure 1](#)). Inorganic constituents and stable isotopes of oxygen, hydrogen, and nitrogen were collected at all sites. Other samples collected include radon at five sites and radionuclides at four sites.

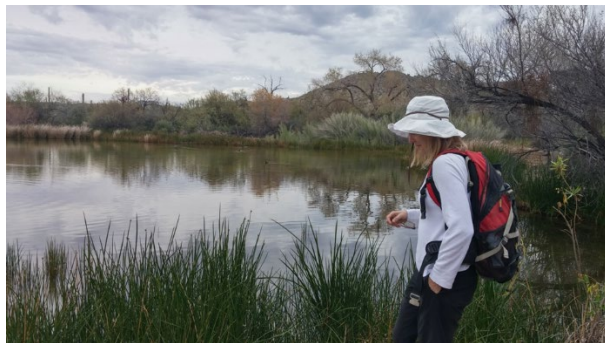
Figure 4 - ADEQ's Elizabeth Boettcher at Quitobaquito Spring, which is critical habitat for the endangered desert pupfish.

The basin is composed of elongated fault-block mountain ranges composed of igneous, metamorphic, and sedimentary rocks with intervening alluvial valleys. All natural waterways are ephemeral, and there are only a few perennial springs, including Quitobaquito Spring ([Figure 4](#)) within the Organ Pipe Cactus National Monument.

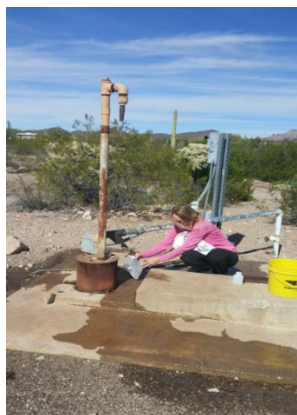
Figure 5 - ADEQ's Elizabeth Boettcher samples South Well #4, which supplies Organ Pipe Cactus National Monument.

ADEQ personnel collected samples from seven sites, five wells and two springs, to characterize regional groundwater quality. The seven sites included Organ Pipe Cactus National Monument South Well (#1) ([Figure 5](#)), Dripping Spring (#2), Quitobaquito Spring (#3), Lukeville Port of Entry Well (#5/6), Gringo Pass

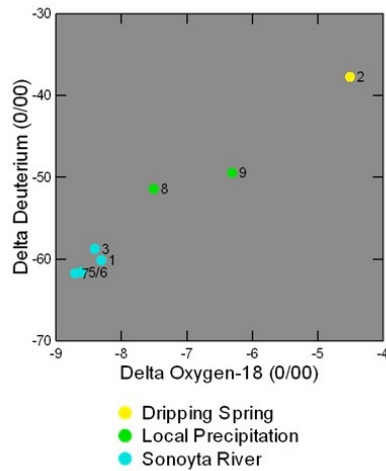
Figure 6 - Stable isotopes values of oxygen and hydrogen reflect precipitation occurring at different elevations and providing groundwater recharge to the sample sites.

$\delta^{18}\text{O}$ and $\delta^2\text{H}$ values at wells and springs in the Western Mexican Drainage basin reflect recharge from local precipitation. However, five samples appear to also have inputs from other recharge sources.

Four of the samples collected in Organ Pipe Cactus National Monument and Lukeville form a tight cluster that are less evaporated than the other samples. An additional recharge source is likely underflow from precipitation that occurred in the headwaters of the Rio Sonoyta, either in the Sierra de El Cobre in Sonora, Mexico or from the Baboquivari Range in the eastern part of the Tohono O'odham Nation. Local precipitation is also a likely component of the recharge for these sites.

The samples collected from two wells located on the Cabeza Prieta National Wildlife Refuge, Papago well (WMD-8) and Tule well (WMD-9), have higher values than the previous samples. These sites match the average values of local precipitation in the area.

Dripping Springs (WMD-2), located within the national monument, is the most evaporated. Evaporation may have occurred before infiltration or after discharge at the spring. The spring is open to the surface, so it might also receive direct recharge from precipitation. If the precipitation occurs during the summer monsoon season, it would also result in higher $\delta^{18}\text{O}$ and $\delta^2\text{H}$ values as summer rainfall has higher values and evaporation is more intense during the summer months.¹⁰
